Inventory No.	PG: 86B-017
---------------	-------------

1. Name of F	Property	(indica	ate preferred n	name)						
historic	Garner-Hyde Ho	ouse								
other										
2. Location										
street and number	11900 Cedarvill	e Road						not f	or publi	ication
city, town	Brandywine							vicir	iity	
county	Prince George's

Garner-Hyde House Continuation Sheet

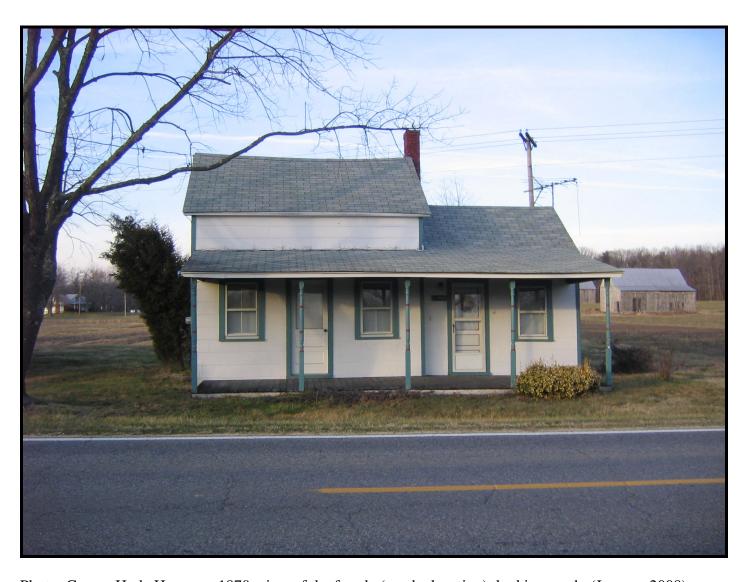
Photo: Garner-Hyde House, c. 1870, view of the façade (south elevation), looking north. (January 2008)

The façade (south elevation) of the Garner-Hyde House is fenestrated by two windows flanking a replacement, single-leaf wood door with square-edge wood surround. The west (side) elevation features a window located in the gable end. The east (side) elevation is fenestrated by a small 4-light casement window located in the gable end, south of the chimney, and features a square-edge wood surround. The north (rear) elevation is obscured by an addition.

A one-story porch extends the full-width of the main block, as well as the eastern addition. The shed-roofed porch is covered with asphalt shingles and is supported by turned wood posts. The gable ends of the roof are clad in asbestos siding. Narrow-width wood planks form the floor of the porch.

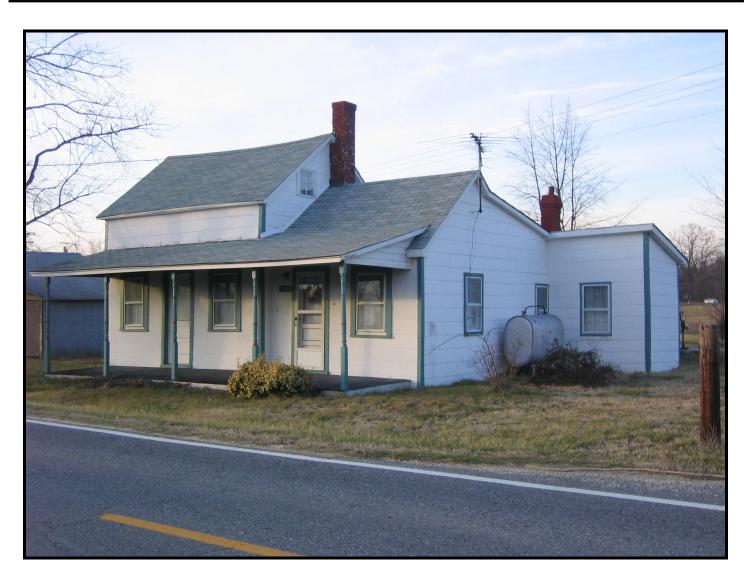
Photo: Garner-Hyde House, c. 1870, view of the southeast corner, looking northwest. (January 2008)

The one-story, three-bay addition to the east (side) elevation of the main block is clad in asbestos siding and capped by a side-gable roof covered with asphalt shingles. The roof features a boxed cornice and shallow overhanging eaves. Based on its form and materials, it appears the addition was constructed c. 1930. Fenestration consists of a 2/2 window flanked to the west by a single-leaf paneled wood door. Fenestration along the east (side) elevation consists of a single 2/2 window.

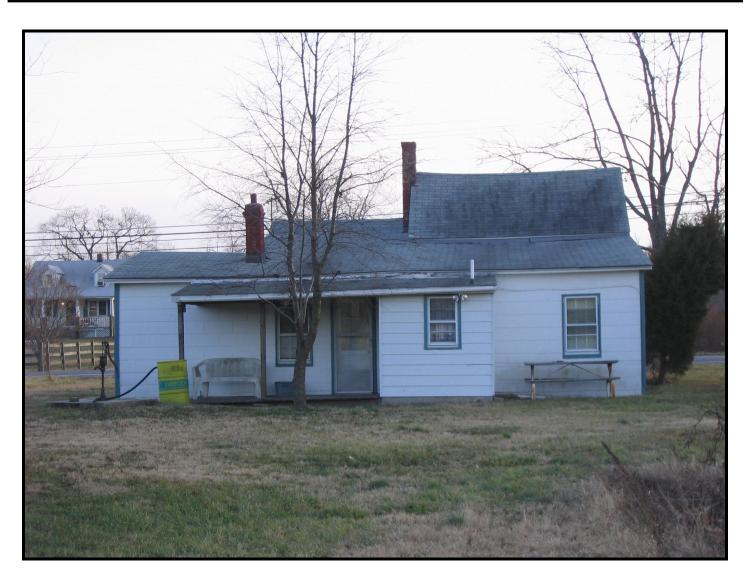
Photo: Garner-Hyde House, c. 1870, view of the north (rear) elevation, looking south. (January 2008)

Located along the north (rear) elevation of the main block is a one-story, six-bay, shed-roofed addition. Based on its form and materials, it appears that this addition was constructed c. 1960. The addition is clad in asbestos

siding capped by a shed roof covered with asphalt shingles. An interior brick chimney with corbeled cap is located in the eastern most bay. The east (side) elevation of the addition is fenestrated by a 6/6 window. The north (rear) elevation is fenestrated by two 6/6 windows flanking a single-leaf wood door. The west (side) elevation is unfenestrated.

A one-story, three-bay porch is located along the north (rear) elevation. Based on its form and materials, it appears the porch was constructed c. 1970. Capped by a shed roof covered with asphalt shingles, the porch is supported by wood posts. The cheeks of the porch roof are clad in vertical board siding. The western most segment of the porch rests on a concrete-block foundation and has been enclosed with asbestos siding and now features a small window located in the north (rear) elevation.

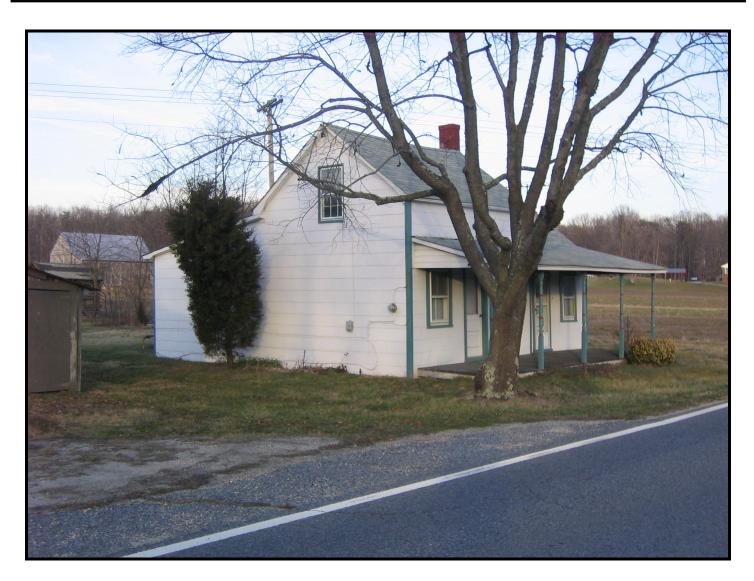
Photo: Garner-Hyde House, c. 1870, view of the west (side) elevation, looking northeast. (January 2008)

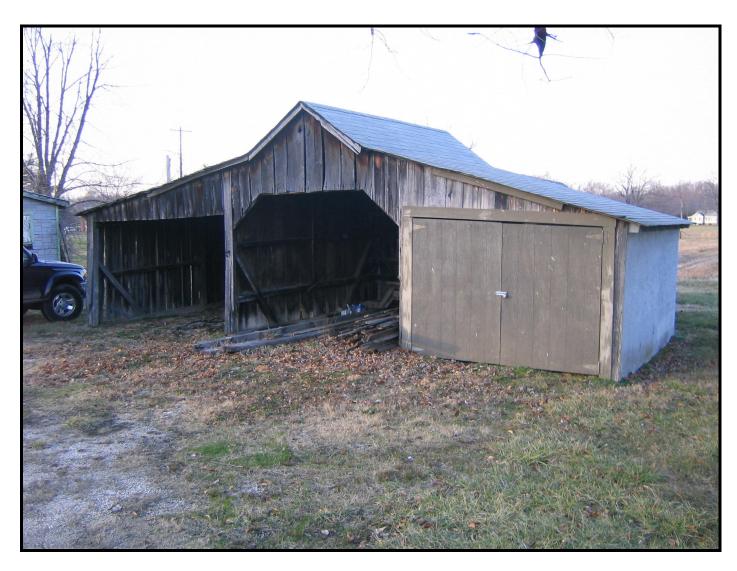
Photo: Garage, c. 1925, view of the façade (south elevation), looking northwest. (January 2008)

A one-story, three-bay garage is located to the west of the Garner-Hyde House. Based on its form and materials, it appears this garage was constructed in the early to mid-twentieth century. This wood-frame structure is clad in vertical board siding capped by a front-gable roof with shed roof extensions to the east and west. The roof is covered with asphalt shingles. The western most bay features a double-leaf wood door with a square-edge wood surround. The eastern most and central bays are open.

The garage maintains a low level of integrity. The building's integrity of design, materials, and workmanship has been affected by the deterioration of original materials and the enclosing of the eastern most bay with a double-leaf plywood door. The garage retains its integrity of association, setting, location, and feeling as it maintains its functionality as a garage for the Garner-Hyde House.

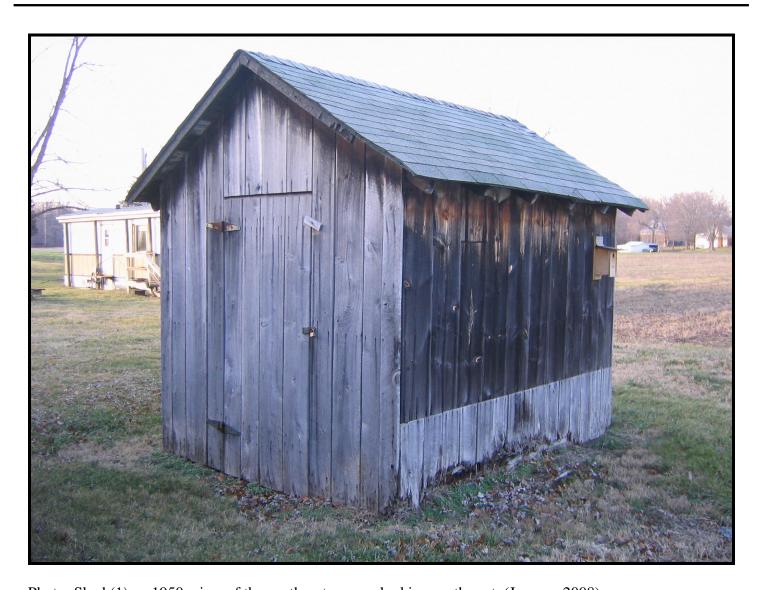
Photo: Shed (1), c. 1950, view of the southeast corner, looking northwest. (January 2008)

Located to the northwest of the dwelling, and directly north of the garage, is a one-story wood-frame shed clad in vertical board siding. Based on its form and materials, it appears this garage was constructed in the mid-twentieth century. This structure is capped by a front-gable roof covered with asphalt shingles, featuring overhanging eaves and exposed rafter tails. A single-leaf wood door is located on the façade (south elevation).

Shed (1) maintains a moderate level of integrity. The building retains its integrity of location, setting, feeling, and association as it still functions as a shed. The shed's integrity of materials, workmanship, and design has been affected, but not compromised by the installation of asphalt shingles, due to the retention of a majority of the original cladding and door.

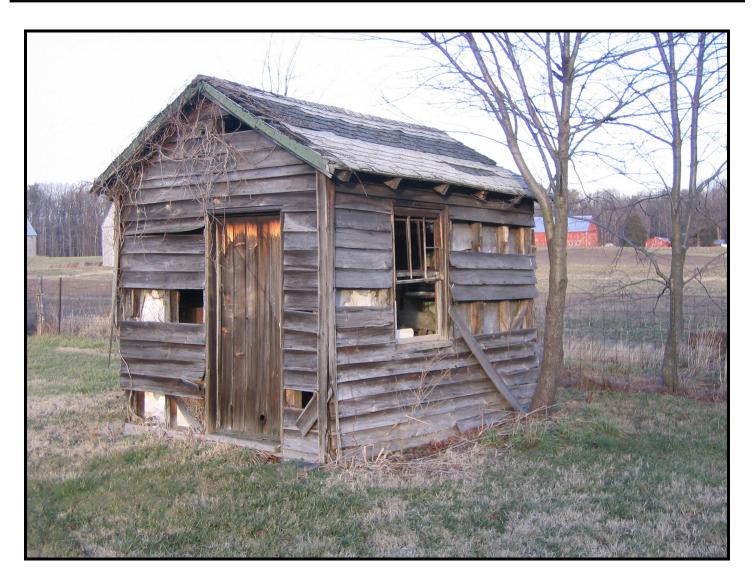
Photo: Shed (2), c. 1950, view of the southwest corner, looking northeast. (January 2008)

Shed (2) is located to the north of the Garner-Hyde House. Based on its form and materials, it appears this structure was constructed in the mid-twentieth century. This one-story, one-bay wood-frame structure is clad in weatherboard siding and features wood corner boards. A front-gabled roof covered with asphalt shingles caps the structure. The roof features overhanging eaves in addition to exposed rafter tails. Fenestration consists of a 6/6 window located on the south (side) elevation as well as a single-leaf batten door on the façade (west elevation).

Shed (2) maintains a low level of integrity. The shed's integrity of association, materials, workmanship, design, and feeling has been compromised due to its vacancy, as well as its poor condition. The shed retains its integrity of location and setting.

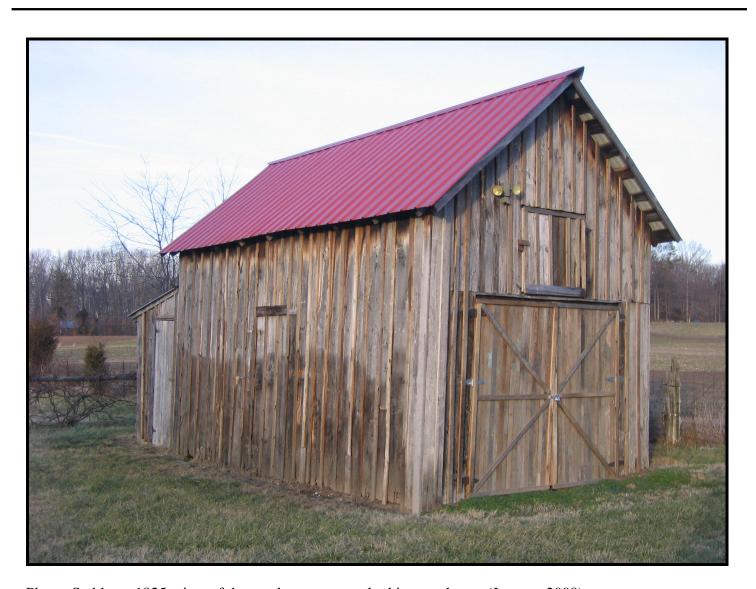
Photo: Stable, c. 1925, view of the southwest corner, looking northeast. (January 2008)

Located to the north of the dwelling, beyond Shed (2), is a one-story, one-bay stable. Based on its form and materials, it appears this structure was constructed in the early twentieth century. Set on a poured concrete foundation, this wood-frame structure is clad in vertical board and capped by a steeply pitched front-gabled roof covered with standing-seam metal. The roof features overhanging eaves and exposed rafter tails. Fenestration on the façade (south elevation) consists of a double-leaf batten door. Centrally located above this is a small, single-leaf batten door. A one-story, full-width addition is located on the north (rear) elevation. Based on its form and materials, it appears the addition was added in the mid-twentieth century. Clad with vertical board siding and capped by a shed roof covered with standing-seam metal, this addition features a single-leaf batten door on the west elevation.

The stable maintains a high level of integrity. The stable retains its integrity of location, setting, feeling, and association as it still functions as a secondary resource for the Garner-Hyde House. The structure's integrity of design, materials, and workmanship has been affected, but not compromised, by the rear addition.

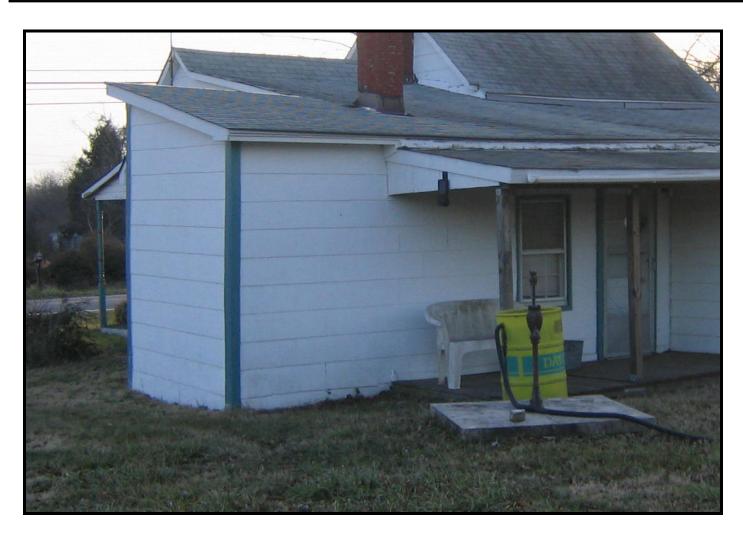
Photo: Well, c. 1950, view looking southwest. (January 2008)

Located northeast, adjacent to the dwelling, is a well. Based on its form and materials, the well appears to have been constructed c. 1950. The well is set on a poured concrete foundation and features a metal water pump.

The well retains a moderate level of integrity. Its integrity of design, materials, workmanship, and location are retained due to its current condition and location close to the dwelling. The integrity of setting, association, and feeling are compromised though due to alterations and additions to the dwelling.
