PISCATAWAY VILLAGE RURAL CONSERVATION STUDY ◆ FEBRUARY 1995

PRINCE GEORGE'S COUNTY PLANNING DEPARTMENT
14741 GOVERNOR ODEN BOWIE DRIVE
UPPER MARLBORO, MARYLAND 20772

TITLE: Piscataway Village Rural Conservation Study - Part II: Village Design Guidelines

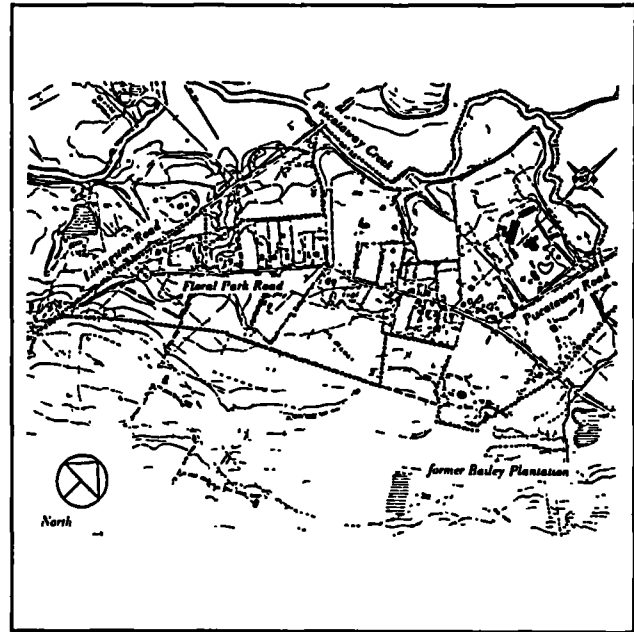
Figure 6: Study Area Boundaries.

Piscataway is located in a stream valley running northeast to southwest across the southwest section of the County (Figure 6). The valley is flanked on the north and south by wooded ridges with heights reaching over 200 feet, compared to elevations of 20 to 40 feet for the village itself. Views from the village are of the wooded, undeveloped ridges to the north and south.

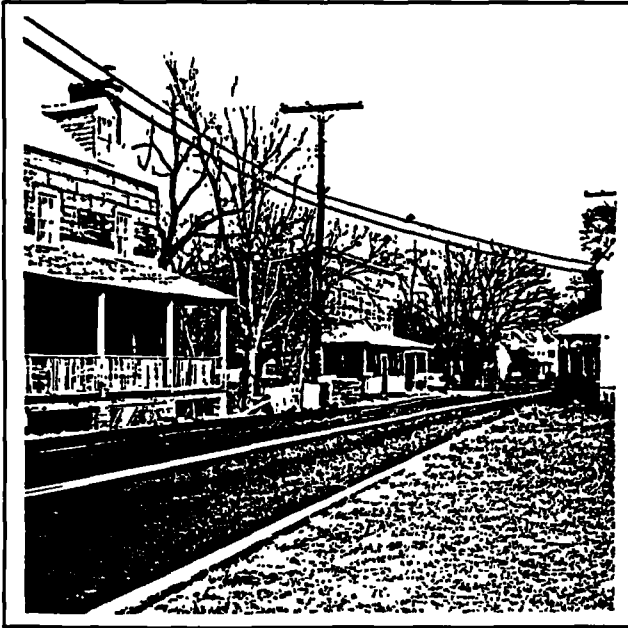
Figure 8: Streetscape along Floral Park Road.

The term "streetscape" refers to the pattern of buildings and other elements (such as trees and fences) that define the street. The streetscape is the public space in the village. The streetscape in the old village center is essentially linear, emphasized by the narrow paved road surface (20 to 22 feet), relatively consistent height of the buildings and close building setback. Buildings are generally 2 to 2-1/2 stories high, with a maximum height of 30 feet. One grouping of buildings is situated very close to the road, with setbacks ranging between 8 and 16 feet. The front porches of these buildings define the road edge (Figure 8). The other grouping of dwellings is set farther back, from 27 to 46 feet, with the roadside defined by fencing or hedges enclosing front yards. All of the buildings except one in the old village center are closer to the road than the minimum 50-foot setback required by the County's Zoning Ordinance in the R-A Zone.

The Piscataway Tavern and the Stanton-Blandford House stand between 3 and 14 feet from the road and form the western gateway into the old village center. The three white, frame dwellings at the east end of the village follow and emphasize the curve in Floral Park Road just before its intersection with Piscataway Road. These changes in the established linear nature of the streetscape are strong elements, forming the special character of the village.

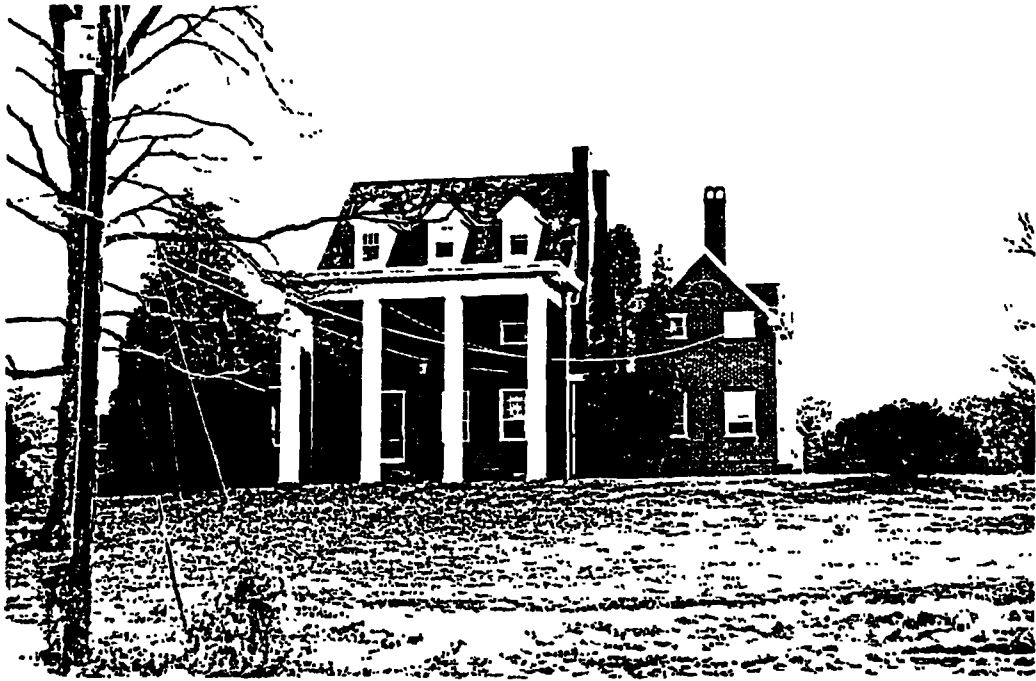
Located on the rising hillside southeast of Piscataway, the Edelen House is a significant landmark. Views of the property have framed and defined the approach to the village from the east and north since the eighteenth century. The house is an imposing structure because of the height of the roof, and the two-story portico and wings added circa 1926. The interior of the main block is a well-preserved example of an 1830s side-hall-and-double-parlor-plan dwelling. It contains an outstanding hanging stairway, and Greek Revival style moldings and mantels on the first and second stories. It represents the Edelen family's long residence in Piscataway

Figure 16: The Edelen House, Historic Site 84-23-6
Figure 17: Plan of the Edelen House Environmental Setting

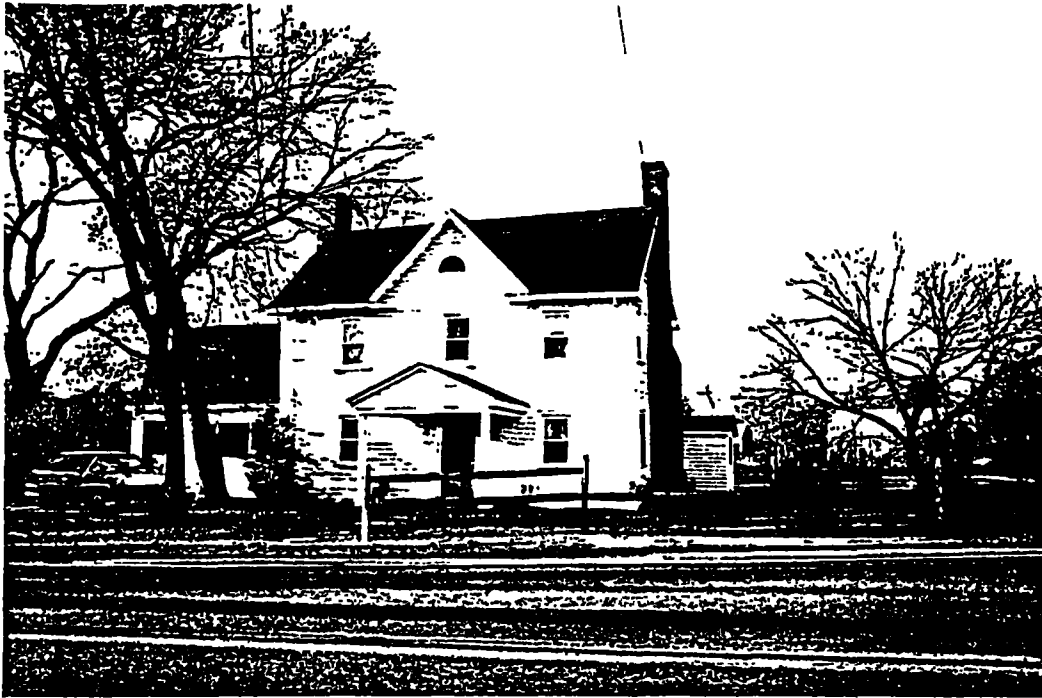
During a 1985 remodeling, the Miller House underwent several significant changes. All of the original multipane windows were replaced with new, single-pane sash windows. In addition, the house was sheathed in artificial siding, which has covered the original wood siding, corner boards and window surrounds.

The Miller House is significant as the former location of the Piscataway Post Office. Located on a prominent corner, the dwelling forms the eastern gateway or entry to the village. The dwelling is an example of late-nineteenth century vernacular architecture. Its central cross-gable and lunette window are repeated on three other dwellings in the village, forming an architectural theme for the dwellings constructed during the later period of the village's history. The frame barn on the property is also significant as one of the few remaining agricultural outbuildings in the village.

Figure 18: The Miller House, Historic Resource 84-23-9
Figure 19: Plan of the Miller House Property

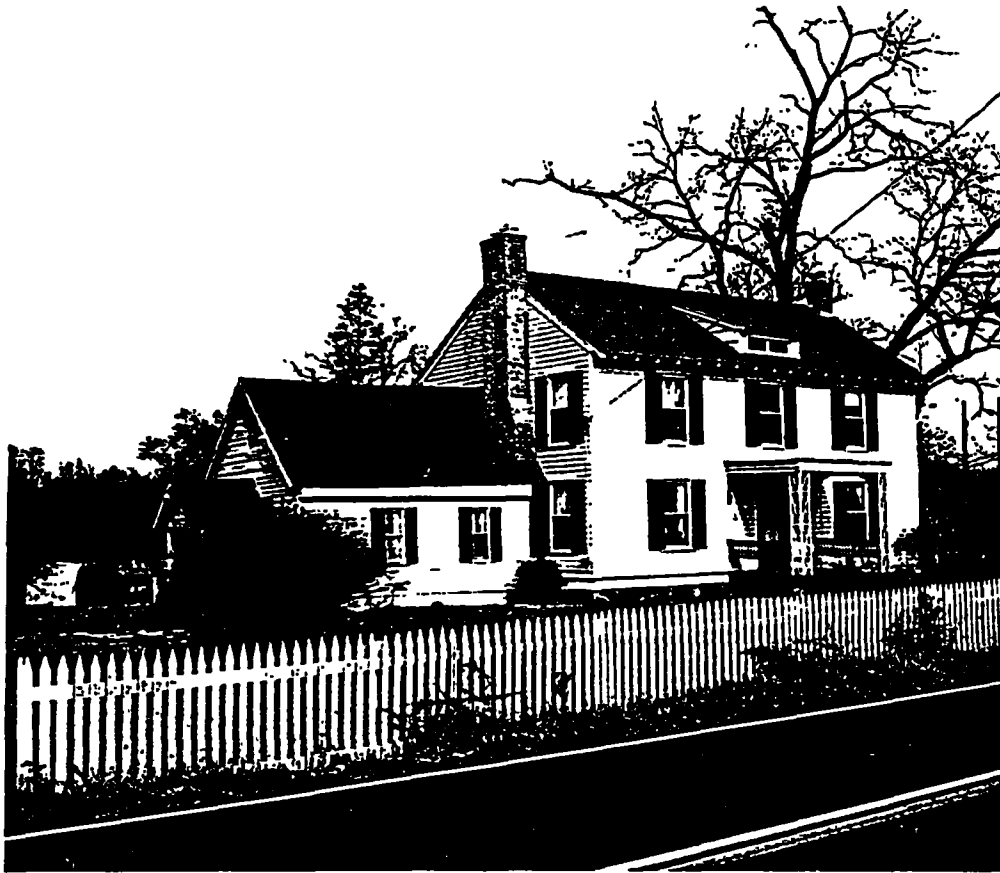
The Hurtt House is significant in that it represents three centuries of construction. Construction details suggest that the first story of the main block dates from the eighteenth century. The kitchen wing was added during the first half of the nineteenth century. In 1912, Dr. Hurtt had the main block raised to its present full 2-1/2 stories. Architectural details such as the variable-width beaded siding on the west wing and the Victorian porch on the main block are important contributions to the character of the village. The house is a local landmark as the house and office of one of Piscataway's best-known citizens.

Figure 20: The Dr. Edgar Hurtt House, Historic Site 84-23-8
Figure 21: Plan of the Dr. Edgar Hurtt House Property

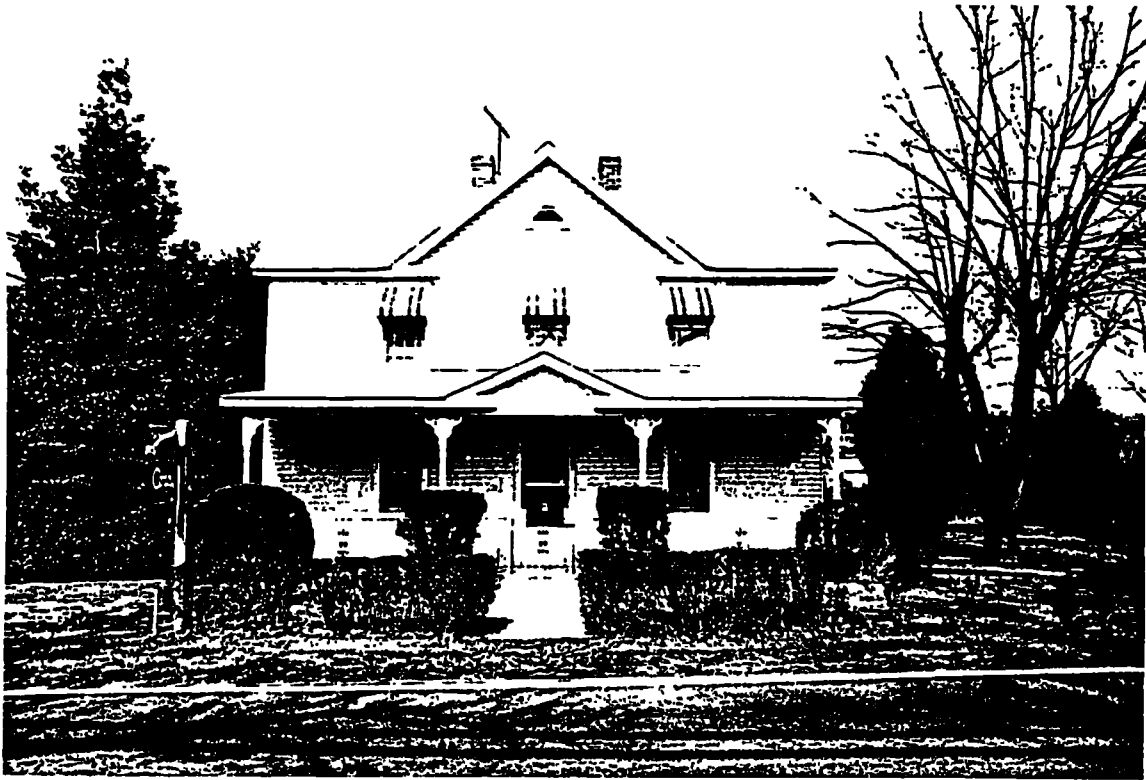
The Gallahan-Davis House in Piscataway is significant as an example of an early twentieth-century dwelling which reflects the Victorian vernacular architectural style of the fourth quarter of the nineteenth century. The dwelling has an I-house plan, one that had been used throughout the nineteenth century in Prince George's County for simple farm dwellings. It is one room deep, having a central hall flanked by a parlor on each side. Two bedrooms on the second floor are above the first floor parlors. The dwelling is embellished by late Victorian stylistic elements, including a central cross gable with a lunette window on the main elevation and a facade-wide entrance porch with turned posts and jigsaw brackets. The dwelling's plan and exterior detail reflect nineteenth- rather than twentieth-century stylistic influences. It is one of the two most recent dwellings in the small cluster that remains of the eighteenth-century village of Piscataway. Because of its architectural style and details, and its location fronting on Floral Park Road aligned with the older dwellings, it contributes to the historic character of the village. The central cross-gable with lunette window is a unifying architectural detail, repeated on three of the other dwellings in the village.

Figure 22: The Gallahan-Davis House, Survey Property 84-23-24
Figure 23: Plan of the Gallahan-Davis House Property

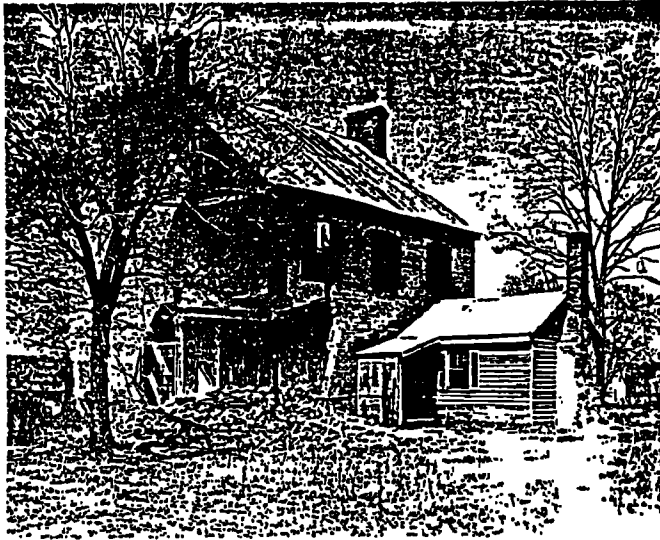
Figure 24

Figure 24: 1936 HABS Photograph, Hardy's Tavern

Now a private residence, this structure is known historically as Hardy's Tavern, a commercial use. The lot on which the building stands was purchased by Isadore Hardy in the 1780s, and before 1798 the house was completed. Hardy operated a tavern on the premises, and his son, William G. Hardy, continued to operate it into the middle of the nineteenth century. It was acquired by the Brandt family just before the Civil War and has been used as a residence since that time. It remained in the hands of family members until 1938. At the time it was sold it was in deteriorating condition. The Historic American Buildings Survey (HABS) photographed the building in 1936 when it stood with its entire southwest corner collapsed through both first- and second-story levels. The dwelling was repaired by new owners and modernized on the interior. It was probably at this time that such features as the present front porch, transom over the main entrance and rebuilt kitchen wing were added.

Hardy's Tavern is significant as an excellent example of vernacular Georgian architecture and the only brick dwelling in Piscataway. Historically, the village was primarily a collection of frame structures. When the tavern was constructed it was the only brick building in the village, and was assessed at three to four times the value of the other farm buildings; contemporary records indicate that it was a substantial and important structure when first built. It is the most substantial building remaining from Piscataway's eighteenth-century past. Other eighteenth-century structures remaining are small frame wings attached to larger, later dwellings. The tavern is important to the village because it represents its thriving, commercial past. Its site plan with a main house and associated outbuildings on the 1.2-acre lot is representative of Piscataway's eighteenth- and nineteenth-century residential pattern.

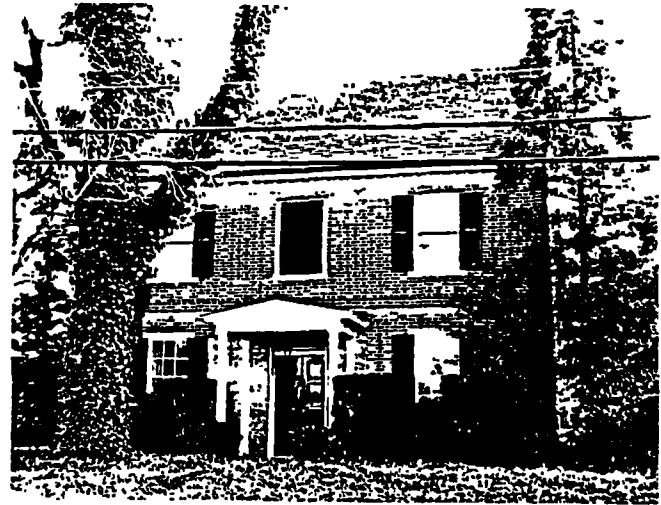
Figure 25

Figure 25: Hardy's Tavern, Historic Site 84-23-5

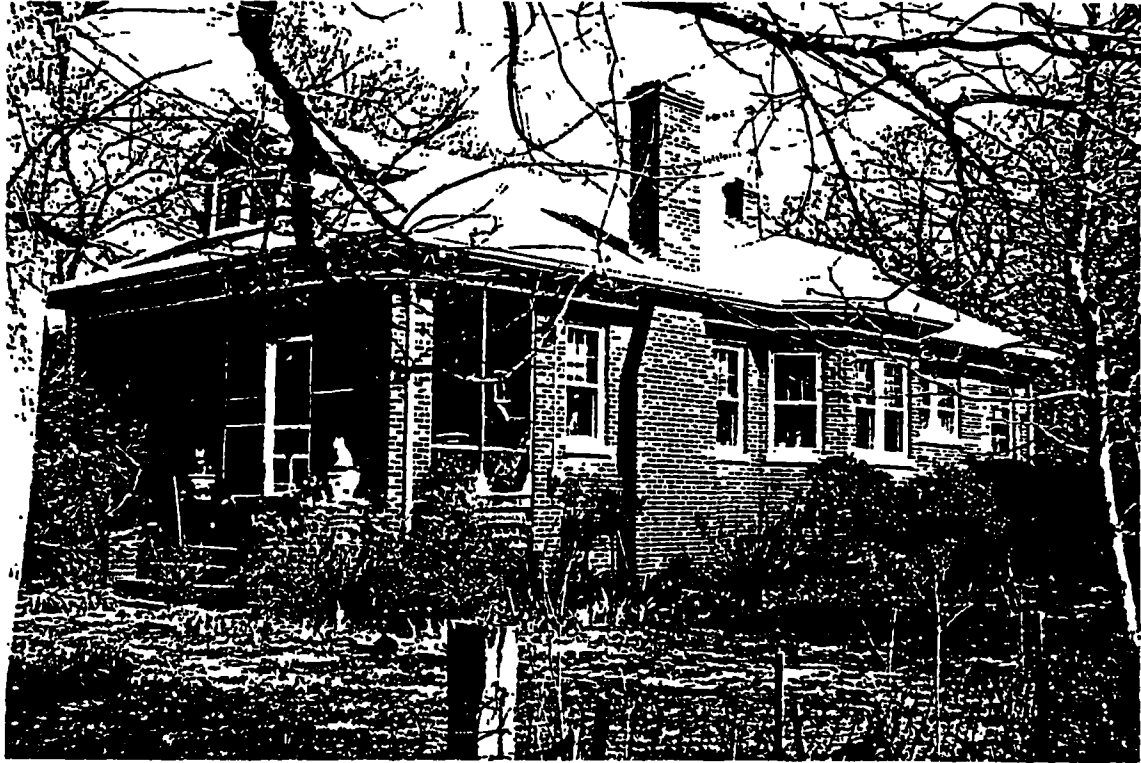
The Bond Bungalow is a good example of a brick bungalow dwelling. Important details include the inset front porch, brick corbelling of the porch support piers, a center front dormer with a molded, returned cornice, overhanging eaves, a corbelled brick chimney, and a semi-octagonal projecting bay.

Figure 27: The Bond Bungalow, Survey Property 84-23-25
Figure 28: Plan of the Bond Bungalow Property

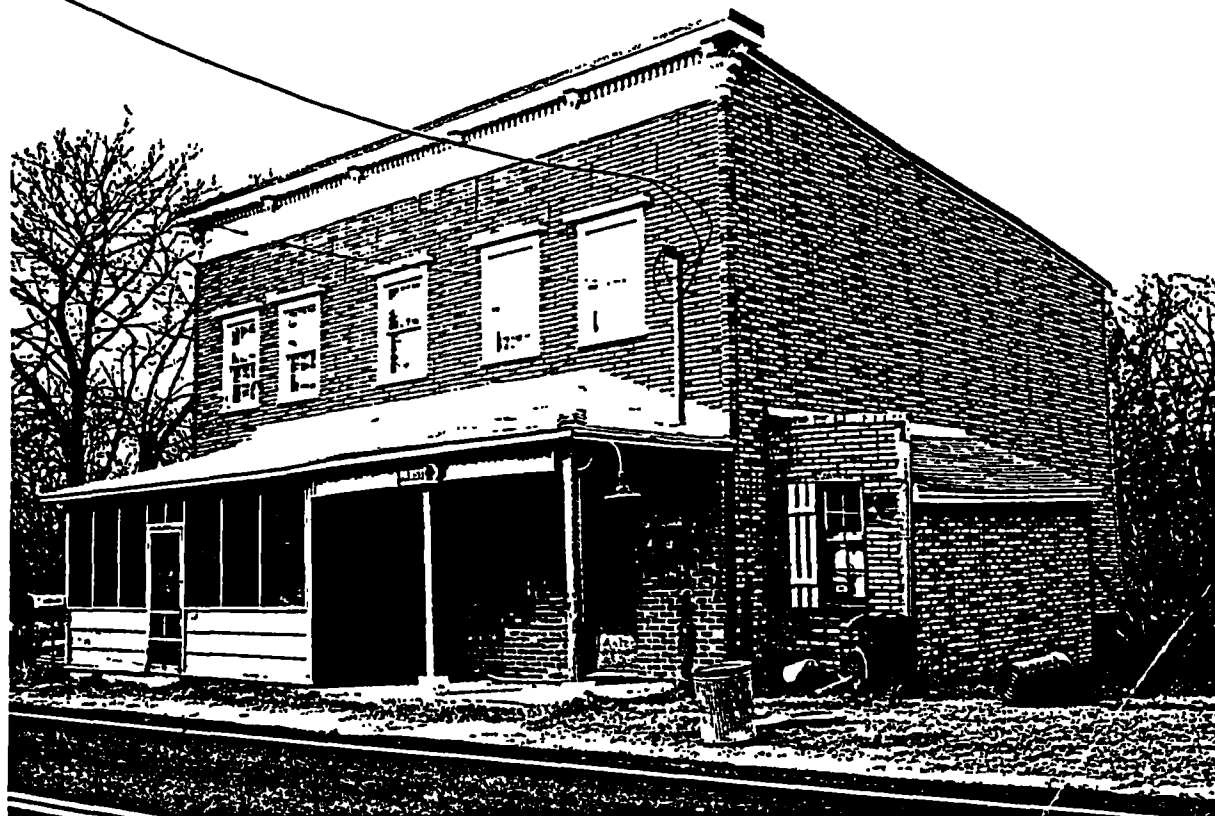
The Harbin House is significant as an example of a structure dating from Piscataway's nineteenth-century role as a small commercial center for surrounding farms. At the time it was built, in the late 1850s, there was no longer a state tobacco warehouse located in the village. There was apparently enough commercial activity to justify the construction of a new hotel, however. The structure was constructed in the Italianate style, a style popular nationally at the time, particularly in urban architecture. It is unusual in rural Prince George's County and forms a prominent addition to Piscataway's streetscape.

Figure 29: The Harbin House (Claggett Store), Historic Resource 84-23-7

A recent remodeling has resulted in the replacement of the original multipane windows with single-pane sash windows. In addition, the house was sheathed in artificial siding, covering up asbestos siding, which in turn was installed over the original wood siding.

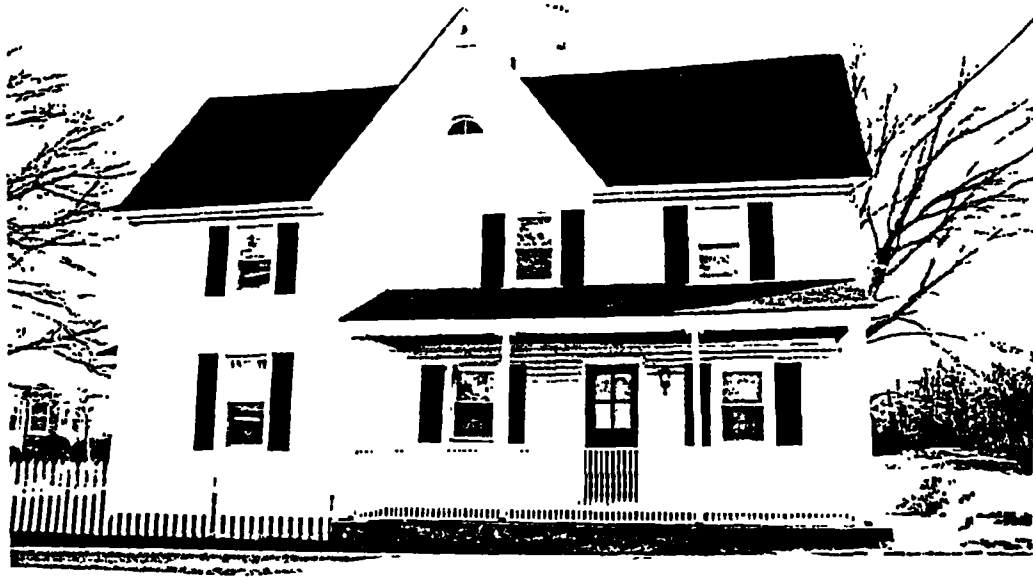
At the time of the construction of the Stanton-Blandford House in 1825, Piscataway was no longer an important tobacco trading center and was shrinking in size and influence. The house is significant as an example of Piscataway's nineteenth-century role as a small commercial center for surrounding farms. The house is architecturally significant as an example of nineteenth-century vernacular architecture with some Greek Revival style details, such as the ornate east porch. It is a significant contribution to village character because of its architectural details and the way it frames the streetscape. The Stanton-Blandford House on the south and the Piscataway Tavern on the north side of Floral Park Road form the western entrance to the old village center. The long "saltbox" roof slope on the Stanton-Blandford House is a very prominent visual feature when the village is approached from the west.

Figure 31: The Stanton-Blandford House, Historic Resource 84-23-4
Figure 32: Plan of the Stanton-Blandford House Property

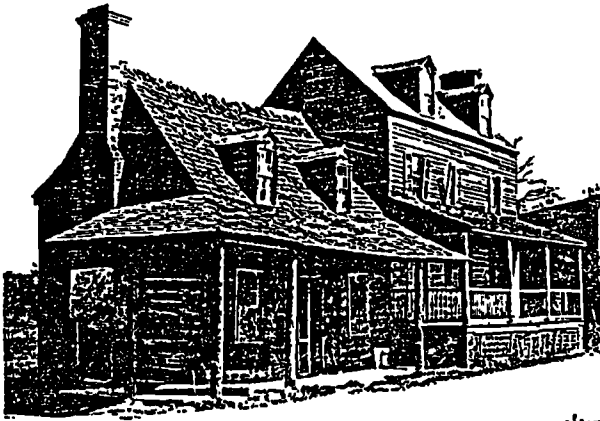
Figure 33

Figure 33: 1936 HABS Photograph, Piscataway Tavern

The tavern displays features which were popular elements of the hand-built architecture of the eighteenth and early nineteenth centuries. These elements include the fieldstone foundation of the east section, which was parged at one time and scored to look like stone blocks, and the exterior east chimney with corbelling at the base, shoulders and cap. The porch sheltering the south facade of the east section has been repaired recently, with a new balustrade and pillars which match the 1936 HABS photographs.

The HABS photographs show old, variable-width wood siding on both sections of the structure. The siding is now covered with deteriorated asphalt siding. The west section has undergone considerable change compared to the 1936 HABS photograph: the dormers have been removed and a single facade-wide dormer constructed in the north roof slope; the wood shingle roof has been replaced with asphalt shingle and the porch sheltering the south elevation has been removed. The house is located at the front of an irregularly-shaped, 10-acre lot, which extends north to Piscataway Creek. A barn is located toward the rear of the property.

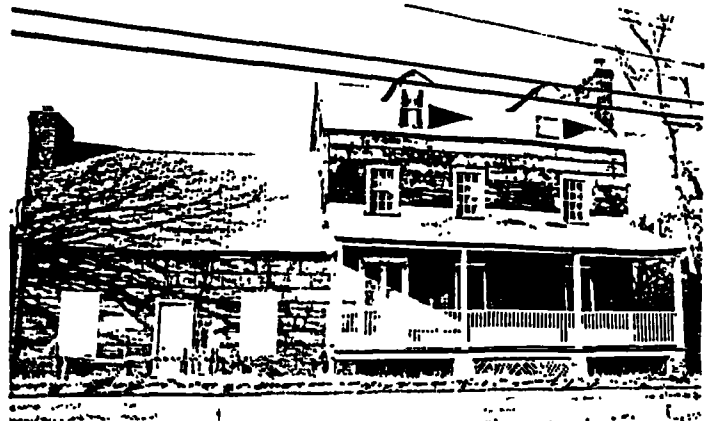
Figure 34

Figure 34: Piscataway Tavern, Historic Site 84-23-3

Although in deteriorated condition, the Piscataway Tavern is outstanding as an example of eighteenth- and early nineteenth-century vernacular architecture in the County. Both the 2-1/2-story, east section and the smaller, older west section are three bays wide, without much architectural adornment. An important feature of the Federal style of the east section are the dormers, which have molded wooden pilasters, round-arched lintels and pediments. Historic American Buildings Survey (HABS) photographs from 1936 reveal that the smaller store section also had two dormers on both planes of the roof. The early photos also reveal a shed-roof porch on the south elevation of the west wing.

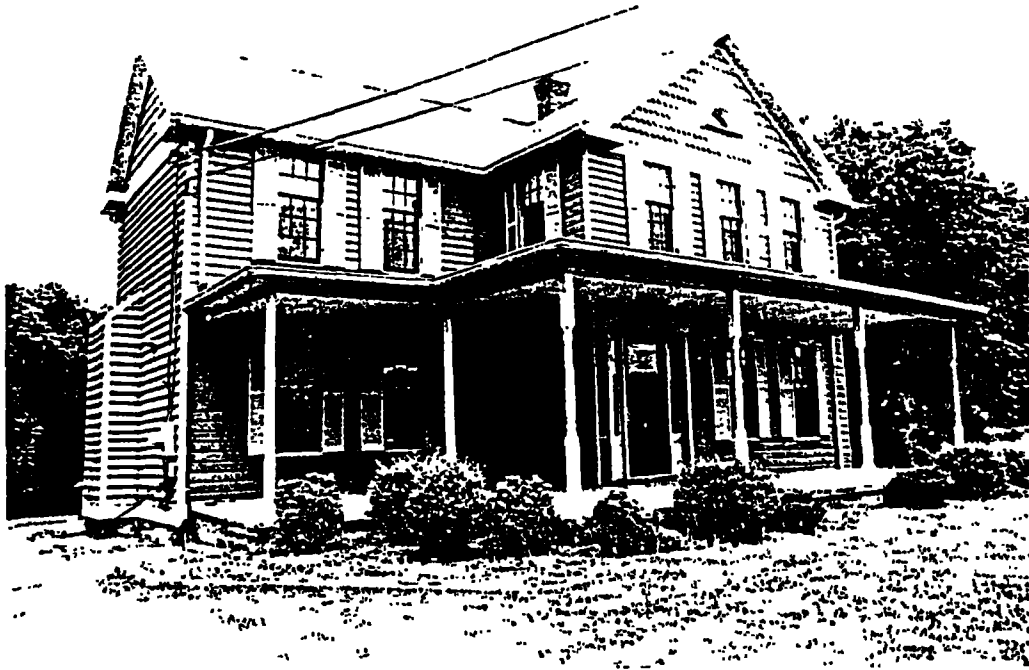
The Underwood House represents the continuation in the early twentieth century of residential construction in the vicinity of the village by members of families associated with the village. It was the first dwelling constructed in the village in the twentieth century. The Underwood House is an excellent example of an early twentieth-century rural dwelling house. Initially very plain, it underwent restoration in the early 1980s and some of the late Victorian and Queen Anne stylistic elements, such as the fishscale shingles in the gable ends, frieze board enclosing the gable ends and large multipane windows on the first story, were added at that time. Because of its handsome profile, decorative detail and prominent siting on a large open lot, it is a visible landmark when one approaches the village from the west.

Figure 36: *The Underwood House, Historic Resource 84-23-2*
Figure 37: *Plan of the Underwood House Property*

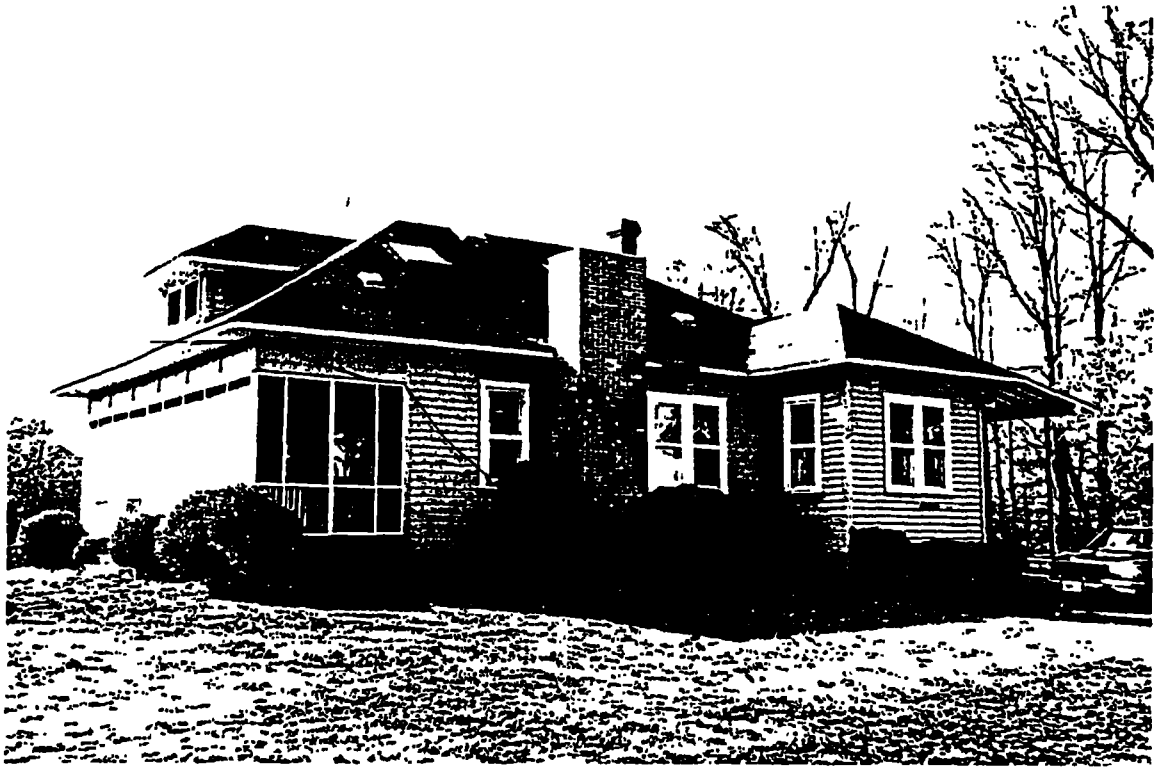
The Thomas C. Underwood Bungalow is significant as a good example of the bungalow style. Its exterior materials and architectural details have been retained in good condition. The dwelling incorporates many elements of the bungalow style, including its one-story height, steeply sloping hipped roof with deeply overhanging eaves, a central dormer, a facade-wide entrance porch incorporated beneath the roof slope, and the decorative use of wood siding in the frieze to give texture and embellishment to the dwelling. Constructed in 1927, the Underwood Bungalow represents the continuation in the early twentieth century of residential construction by members of families associated with the village of Piscataway.

Figure 38: The Thomas C. Underwood Bungalow, Survey Property 84-23-26
Figure 39: Plan of the Thomas C. Underwood Bungalow Property

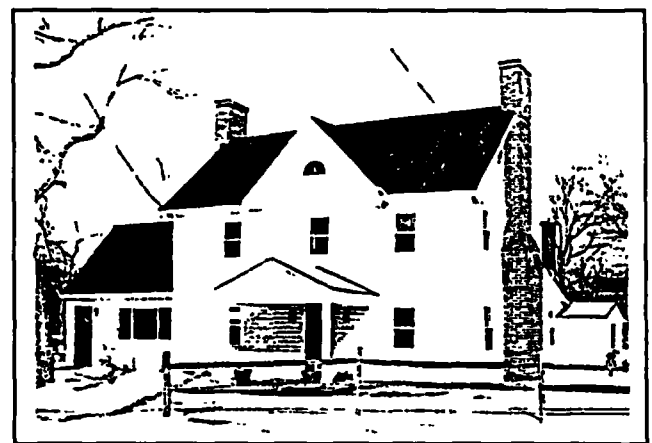
Figure 44: Miller House addition

Almost all of the historic buildings in the village have had additions over the years, as the needs of the occupants changed. These additions have followed the general guidelines outlined below. They are all to the side or rear of the main block. They are smaller, simpler structures than the main block, and of similar construction materials (Figure 44).

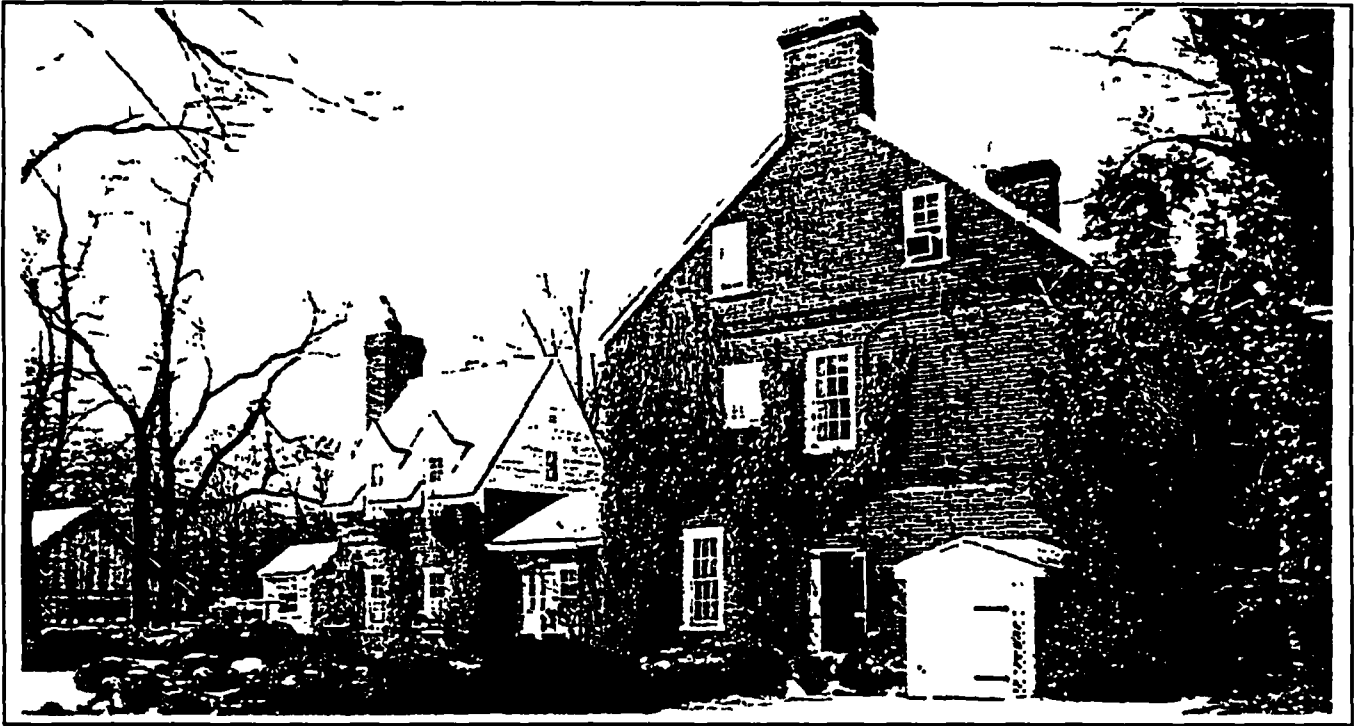
Figure 45: Hardy's Tavern addition

Additions should be located at the rear of existing buildings or on side elevations that are not readily visible from the street (Figure 45). This includes new rooms, porches, decks and stairs. Existing porches which are significant elements of a building's architectural expression should not be enclosed for additions because of the impact such enclosures would have on the visual character of a structure.

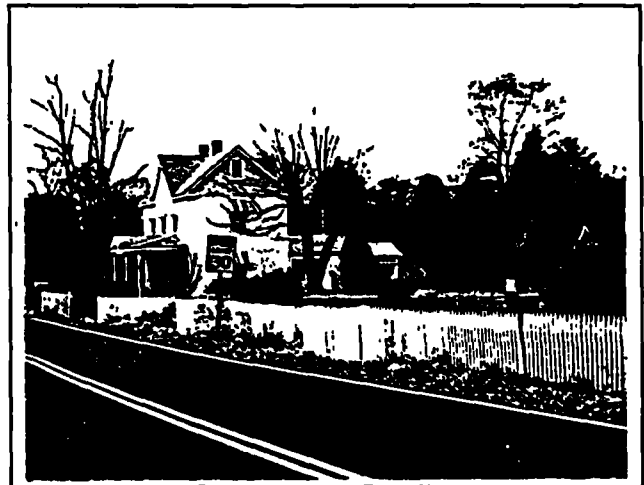
Figure 47: Fences

Fences along lot lines and the street frontage of an historic property should be made of fencing material appropriate to the eighteenth, nineteenth or early twentieth century. For example, wood picket or rail fences and stone walls would be appropriate for most houses in the village. The use of wrought iron fencing may be appropriate for some houses, particularly Victorian houses, but this material is much more common in an urban environment and may seem out of place in a rural village (Figure 47).

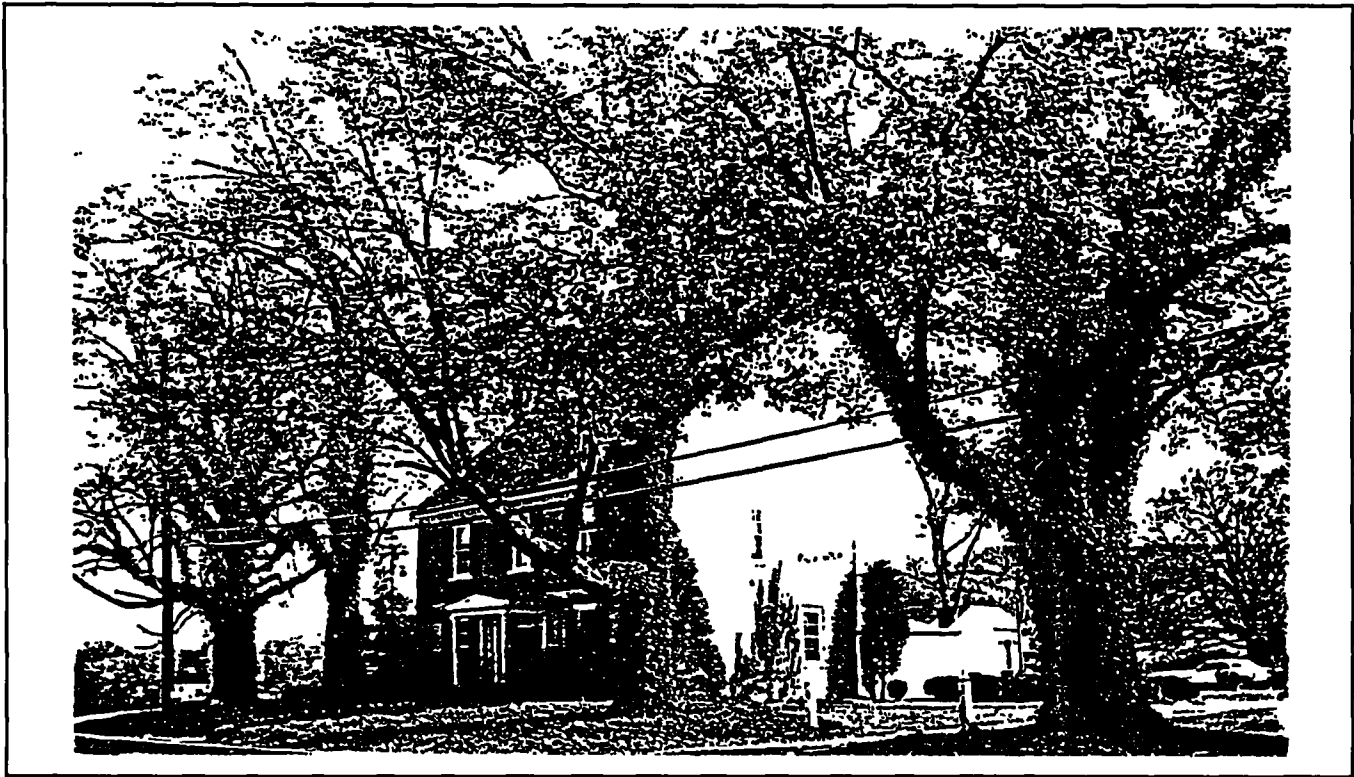
Figure 48: Mature landscaping helps define the village character

Mature trees and shrubs in the village should be retained. These help a new building fit into the streetscape and appear "established" (Figure 48).

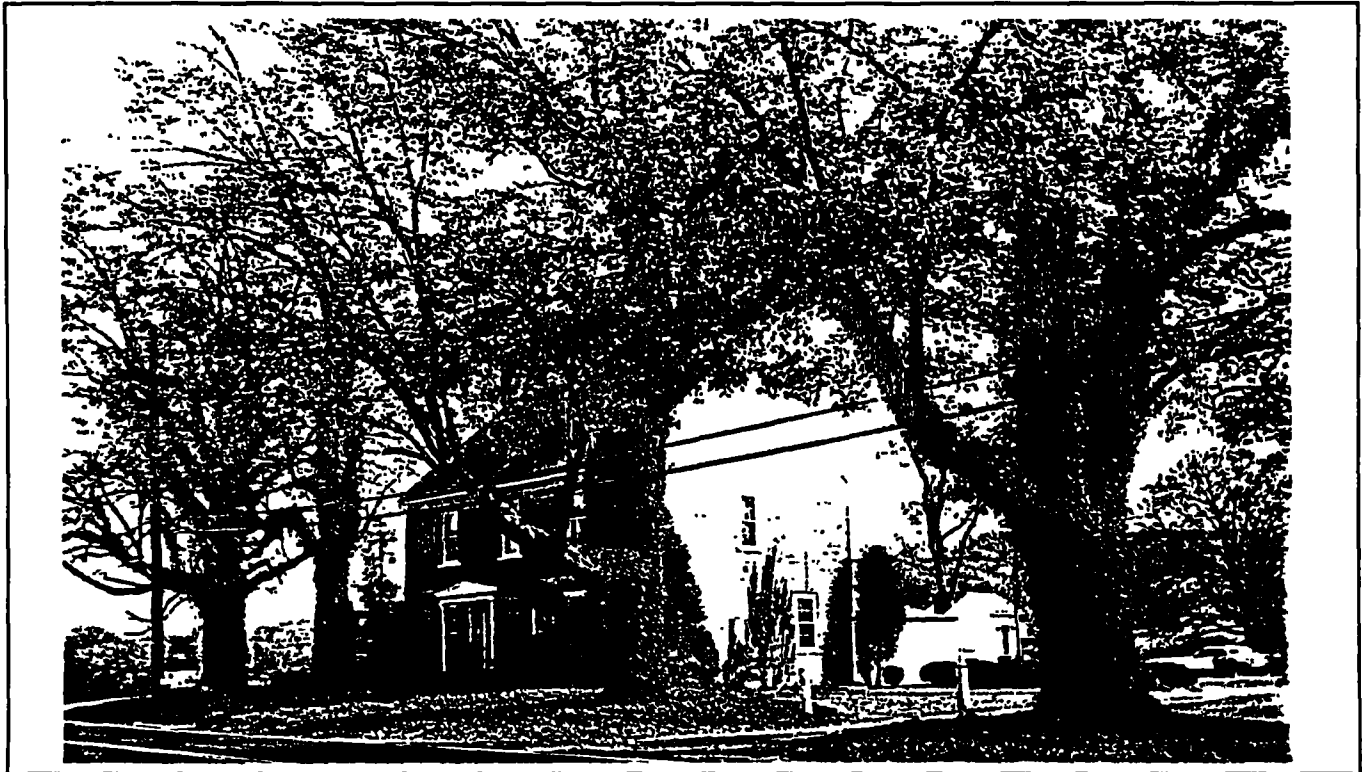
Figure 51: Hardy's Tavern Georgian architectural details.

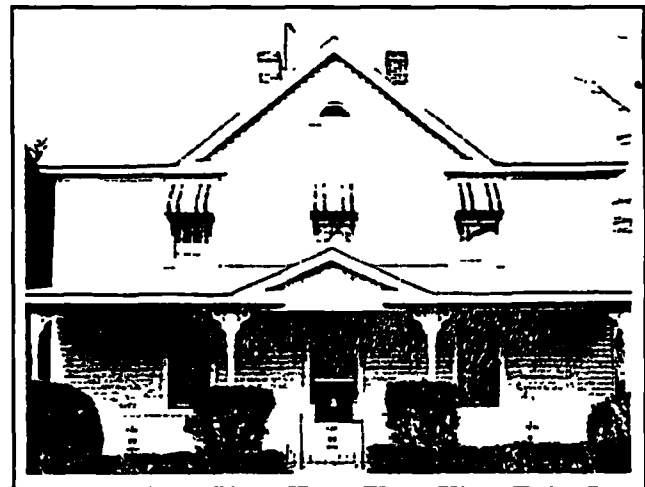
Figure 52: Gallahan-Davis House architectural details reflect the Victorian era.
